Birkdale Community Association  
Capital Improvements Committee

# PATHS/WALKWAYS SUB-COMMITTEE

# REPORT

March 7, 2024

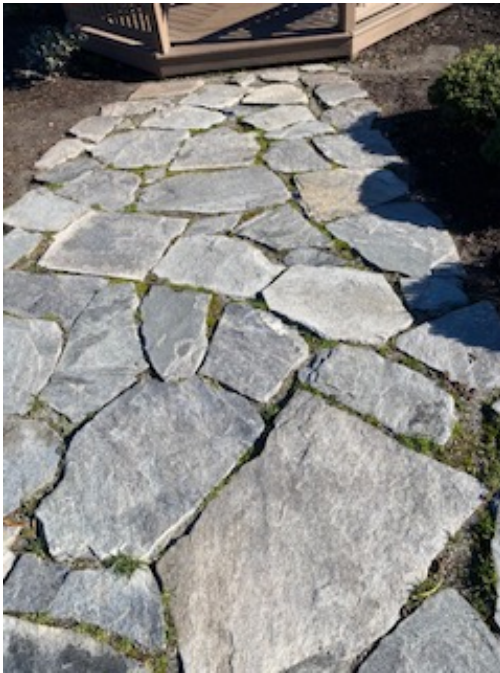
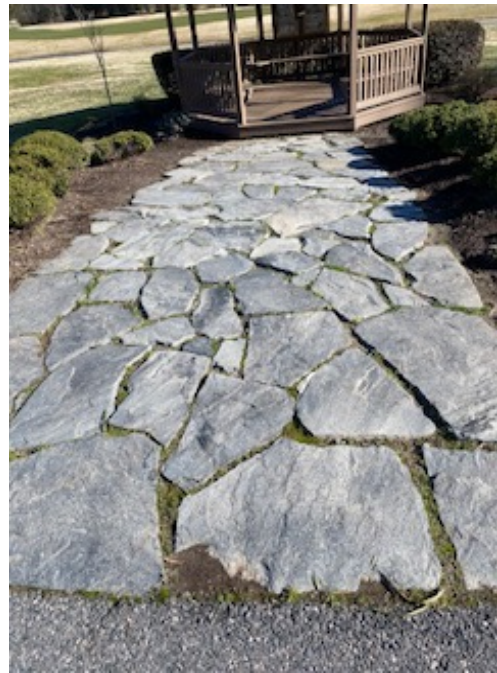
The flagstone paths are aesthetically pleasing; however, the irregular stone surfaces, loose stones, and overall unevenness can be trip/fall hazards.

Royal Birkdale gazebo flagstone path

9. **PRIORITY:** Immediate attention for replacement of both flagstone paths at the Royal Birkdale gazebo and Avalon gazebo.
10. **PRIORITY:** Replace/repair paths/walkways from Spyglass Hill Circle to Ashbourne Hollow.

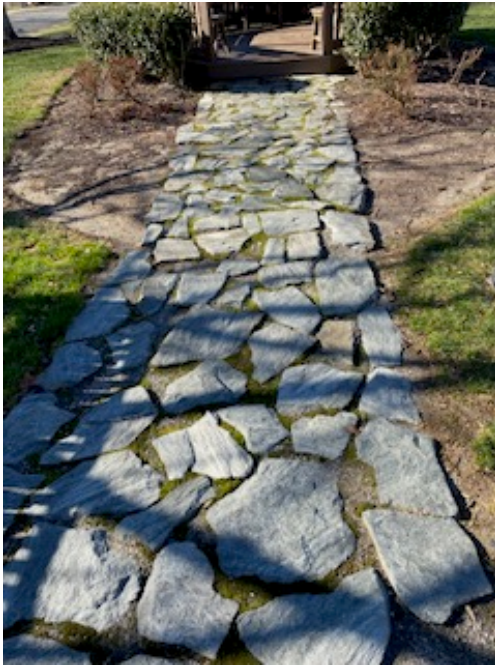
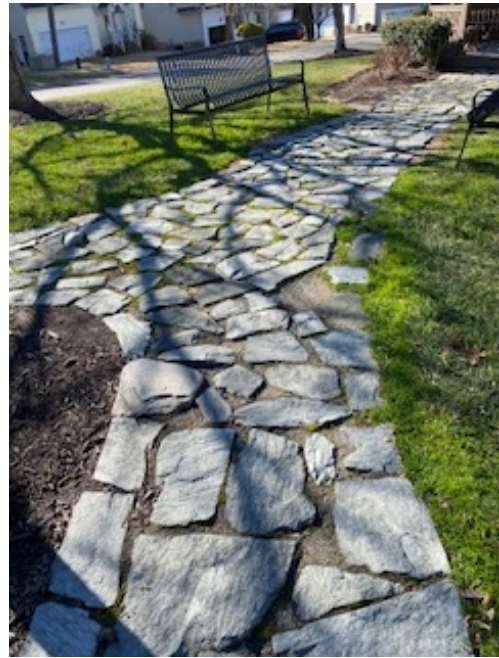
Avalon Gazebo flagstone path

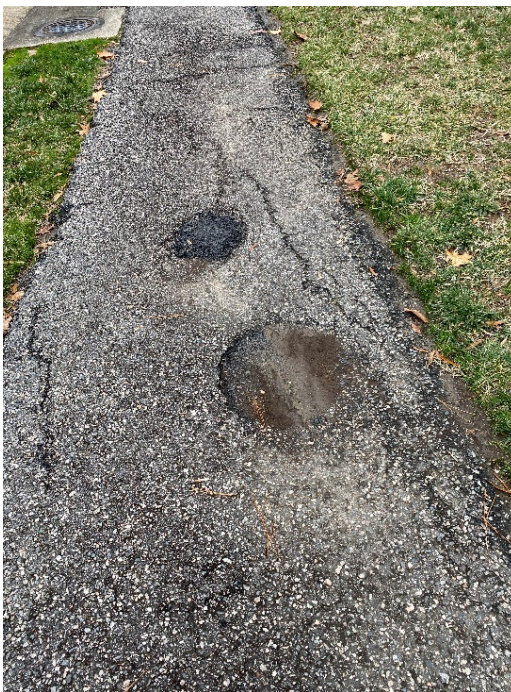
Potholes

11. **PRIORITY:** Patch/fill/repair “bad” areas with tree root eruptions, severely cracked areas, and potholes.
12. **PRIORITY:** Address the severe slopes of the paths from Spyglass Hill Circle to Torrey Pines and on Royal Birkdale Drive from the dam to the Royal Birkdale gazebo.

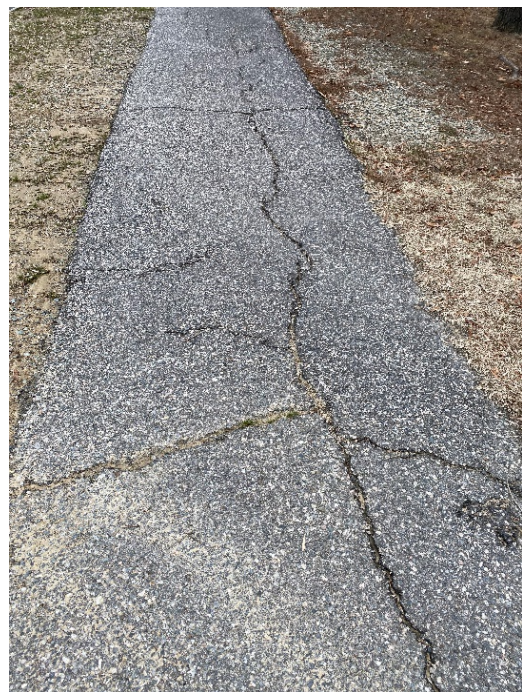
Cracks and grass/weeds

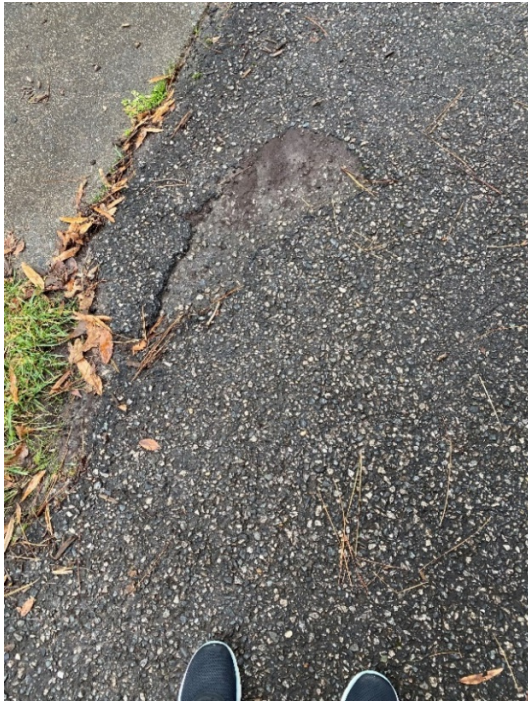
Hole

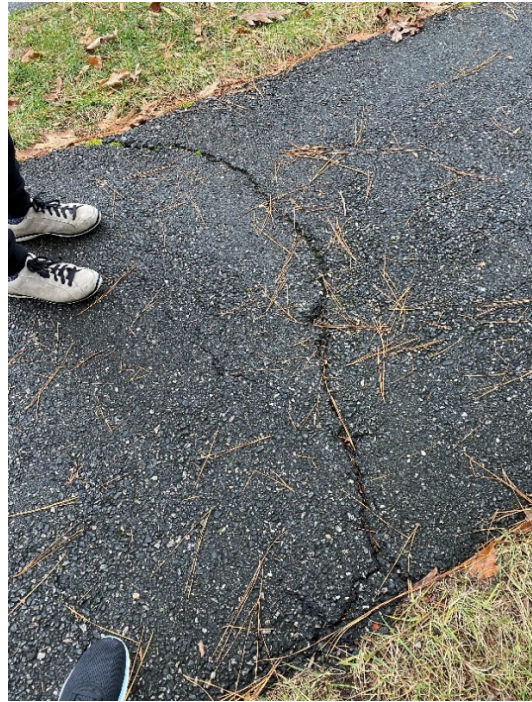
Crack

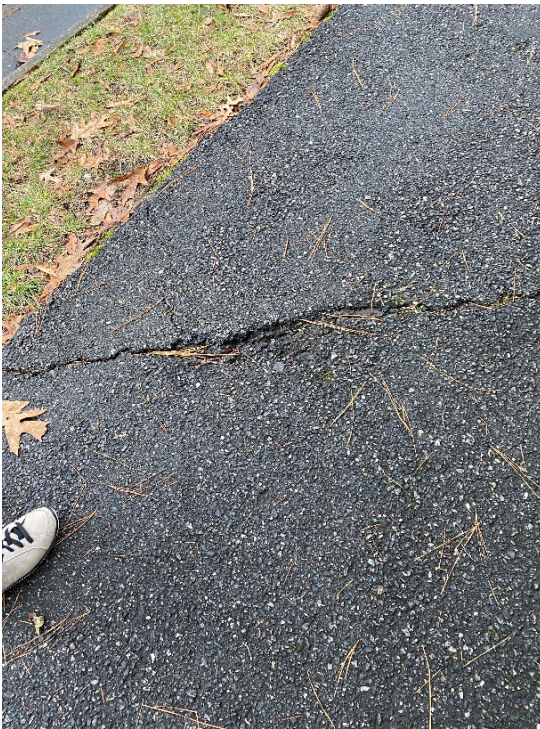
Crack

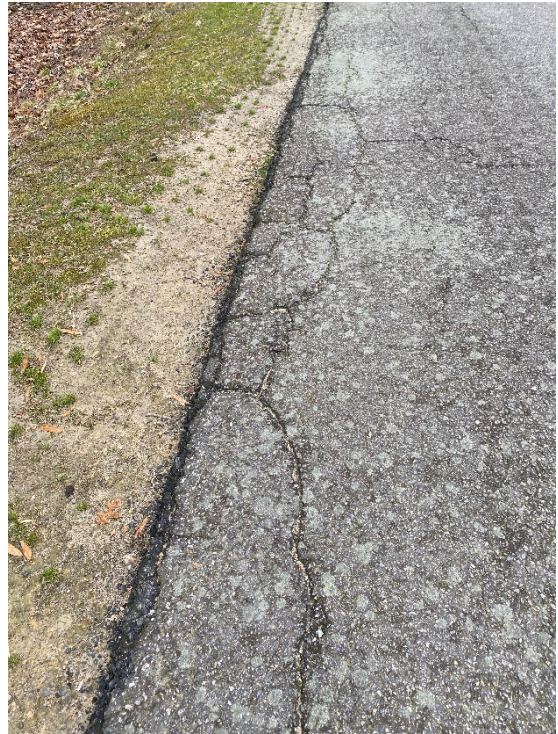
Edge drop-off &amp; cracks near Birkdale Golf Club

5. Reduce the steep angle in sections of the paths.
6. Renovation/repair should address areas where the asphalt is higher than the surrounding ground—especially the pavement edges.

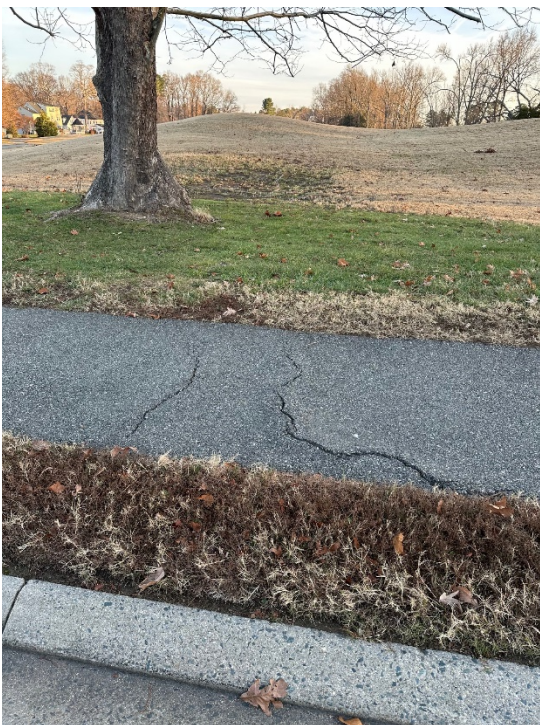
Roots and cracks near #1 golf course hole

2. Consider sealing the asphalt.
3. Paths should be a consistent width of five feet.
4. Tree roots causing damage to paths must be removed and excavated appropriately to reduce further damage to the paths.

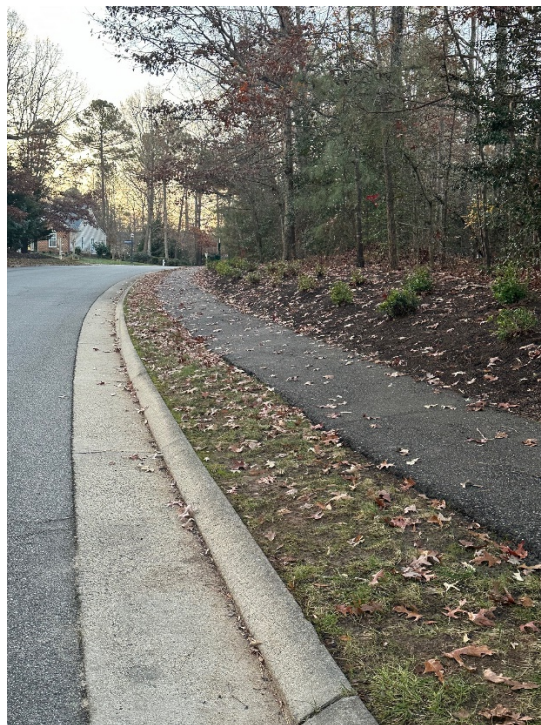
Steep angle of path

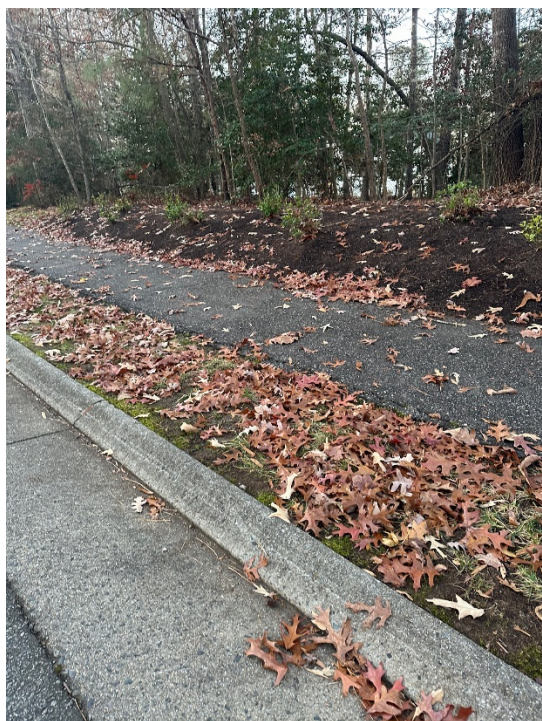
Steep slope of path near Ashbourne Hollow

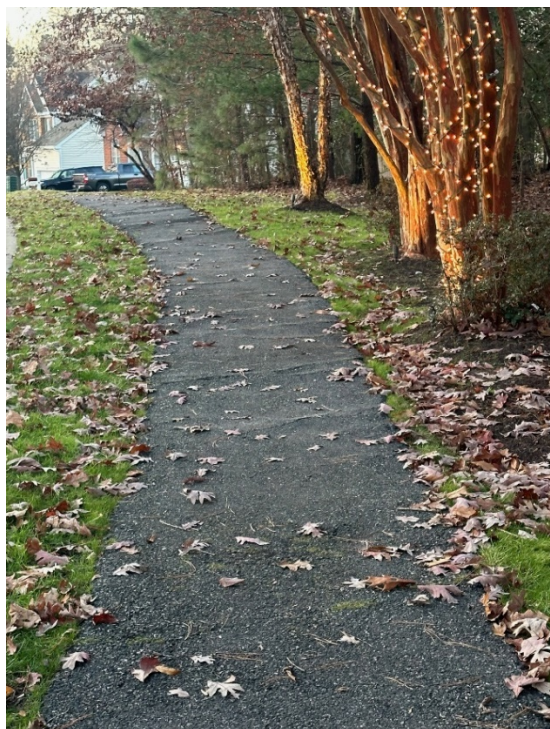
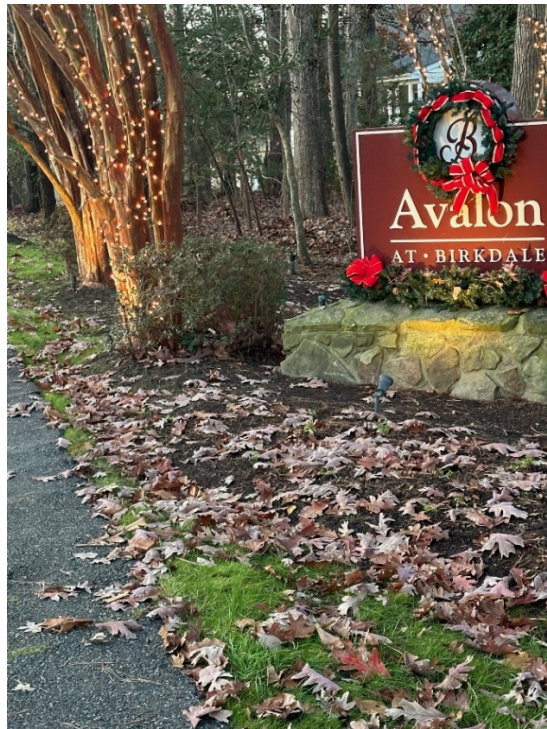
Avalon near Spyglass Hill Circle: narrow, sloped and irregular path

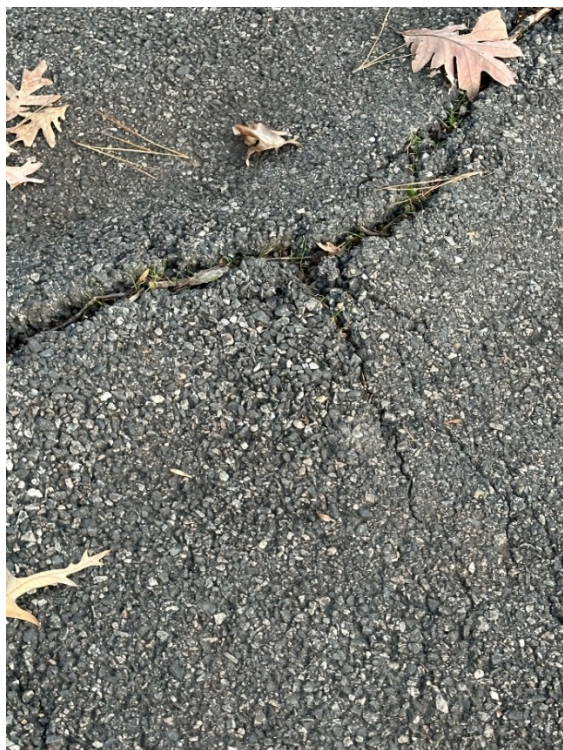
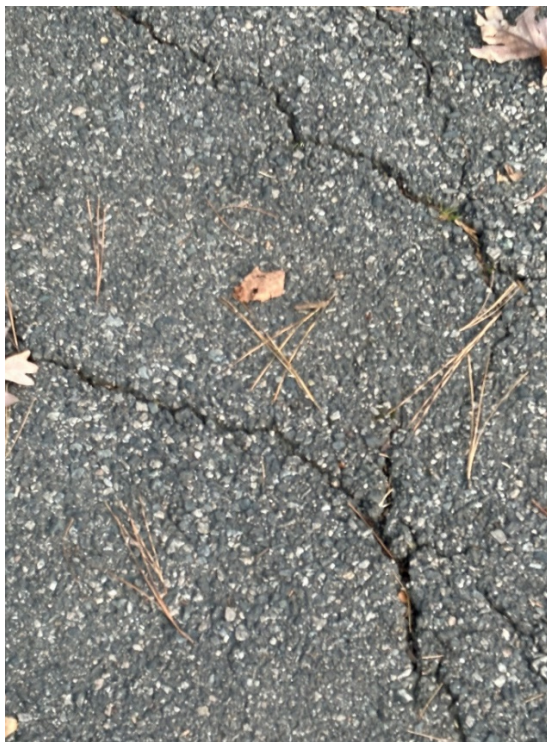
Cracks
