Birkdale Community Association  
Capital Improvements Committee

# PATHS/WALKWAYS SUB-COMMITTEE

# REPORT

March 7, 2024

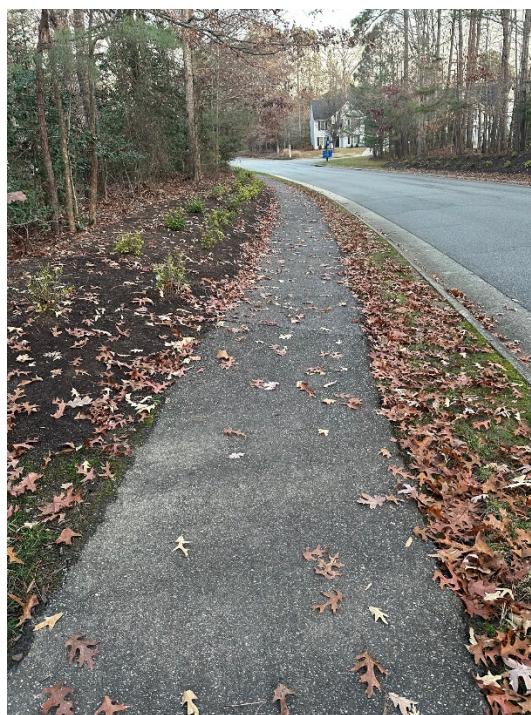
Steep slope of path near Ashbourne Hollow

11. **PRIORITY:** Patch/fill/repair “bad” areas with tree root eruptions, severely cracked areas, and potholes.
12. **PRIORITY:** Address the severe slopes of the paths from Spyglass Hill Circle to Torrey Pines and on Royal Birkdale Drive from the dam to the Royal Birkdale gazebo.
